THE GREAT UK ANTIFOULING SHOWDOWN

20 paints tested in 13 UK locations: which works best where you keep your boat?

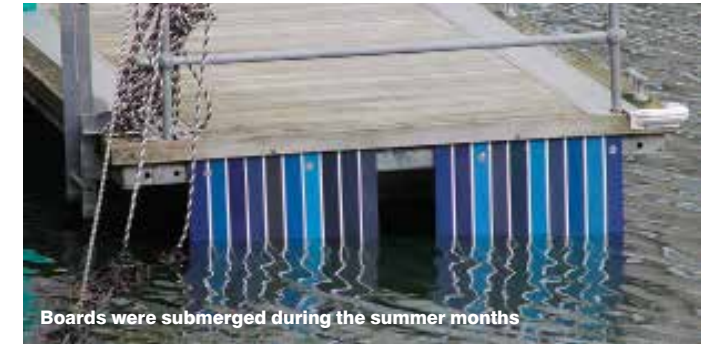
Boards were submerged during the summer months

possible. We installed the boards in late March, returning in early October to remove them and inspect the results.

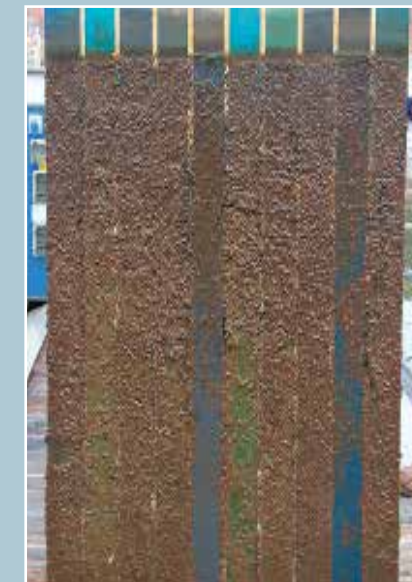
A board from Whitby as removed, showing how the slime ran off the two Seajet products, 038 and 033

These paints shed slime and other fouling so effectively in many places that when

pulled out of the water, they appeared clear. Other paints also performed reasonably well. International's Micron Extra was a comfortably one of the top paints all around the country. Other good performers included Teamac Antifouling D plus, made by an independent family business located in the north-east, Precision Premium, also made by Teamac, and Nautix's A3. Seago High Performance also performed well in places. Hempel's Cruising Performer and Jotun's NonStop did well in some areas of the country. Boero's Mistral NF had some reasonable results, and Flag Performance Extra did well on the East Coast.
